**ANALYSIS OF USABILITY AND ACCESSIBILITY FEATURES IN PUBLIC  
BUILDINGS: A CASE STUDY OF HOSPITALS IN AKURE, NIGERIA.**

**OYEKUNLE IYINOLUWA TOLUWANIMI**

**DEPARTMENT OF ARCHITECTURE,**

**THE FEDERAL UNIVERSITY OF TECHNOLOGY AKURE, ONDO STATE, NIGERIA.**

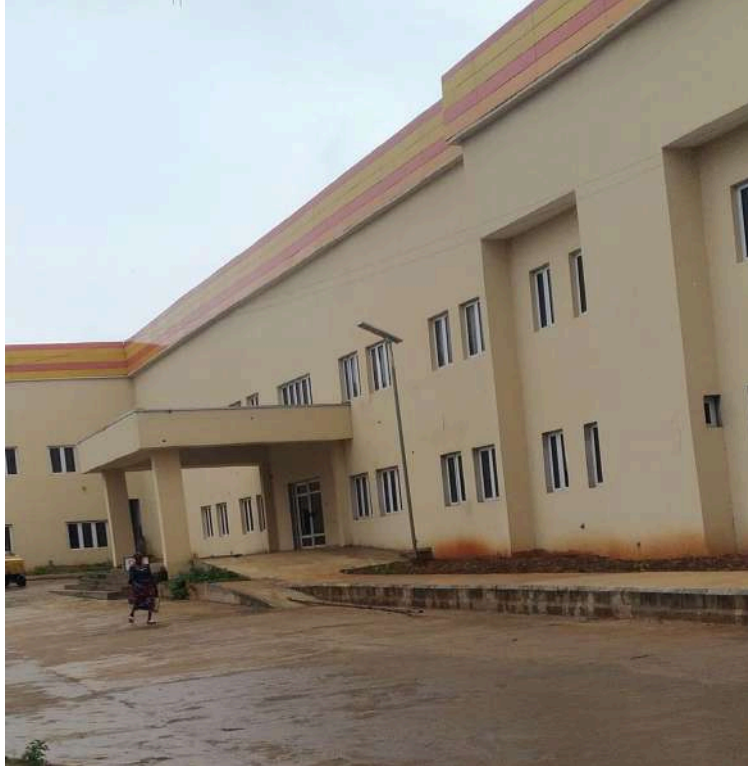
Upon entry, a large two-story building is being constructed, almost at the edge of completion. This is the new building for the hospital's healthcare services for its target demographics. However, it has yet to be open for use, so an evaluation was not made of this building. However, accessibility features like ramps were used at the main entrance of the building, although positioning might have been a problem.

*Plate 1: The new building's entrance with ramps*

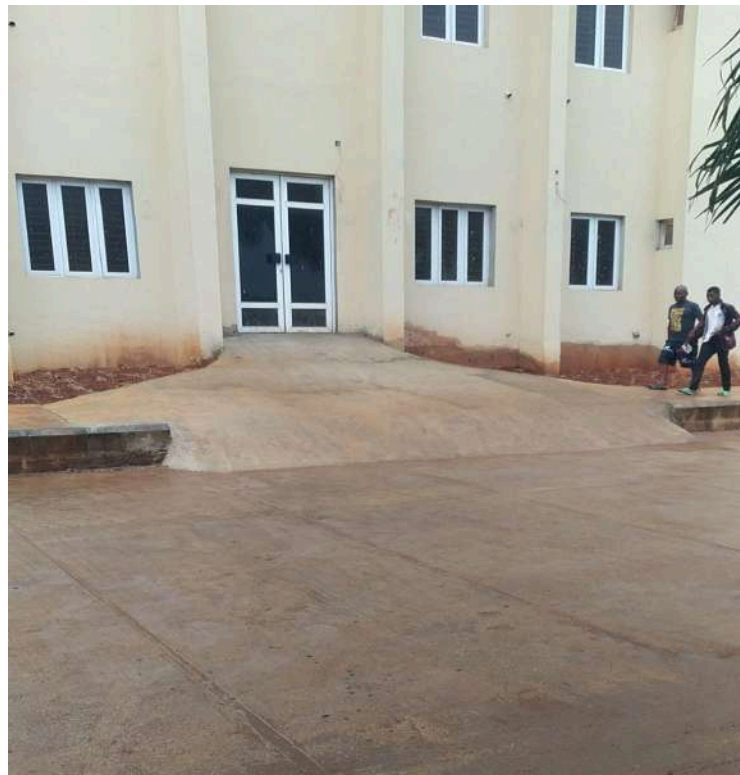
*Plate 2: The pedestrian entrance to the new hospital building*

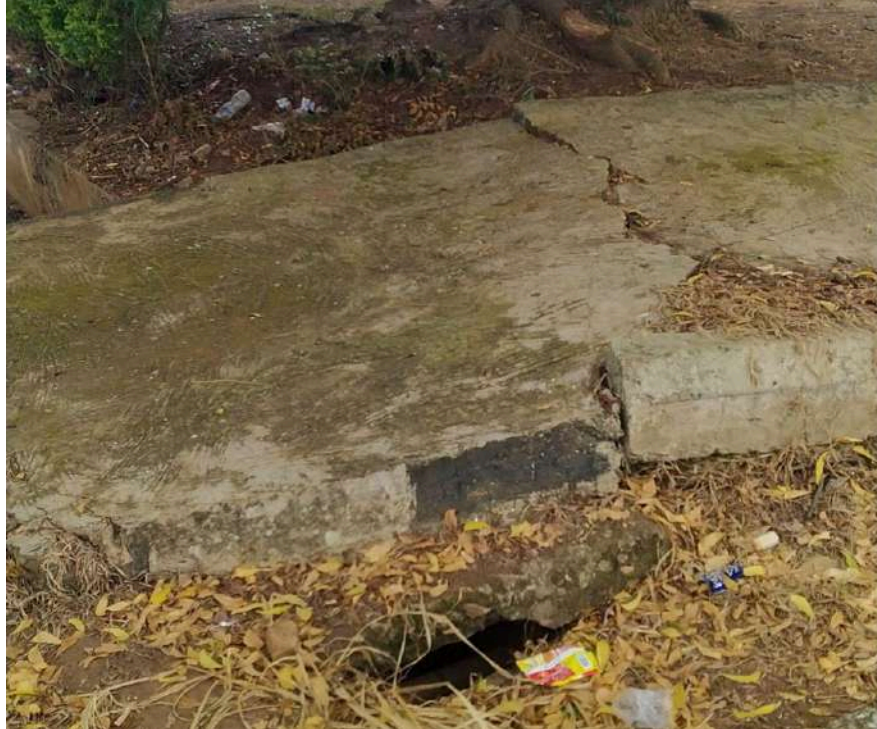
Some of the accessibility features present in these buildings include walkways directly connected to the road, ramps connecting the major walkway to buildings around it, and ramps from the road to the entrance of specific buildings.

*Plate 3: A walkway with a ramp connected to the road*

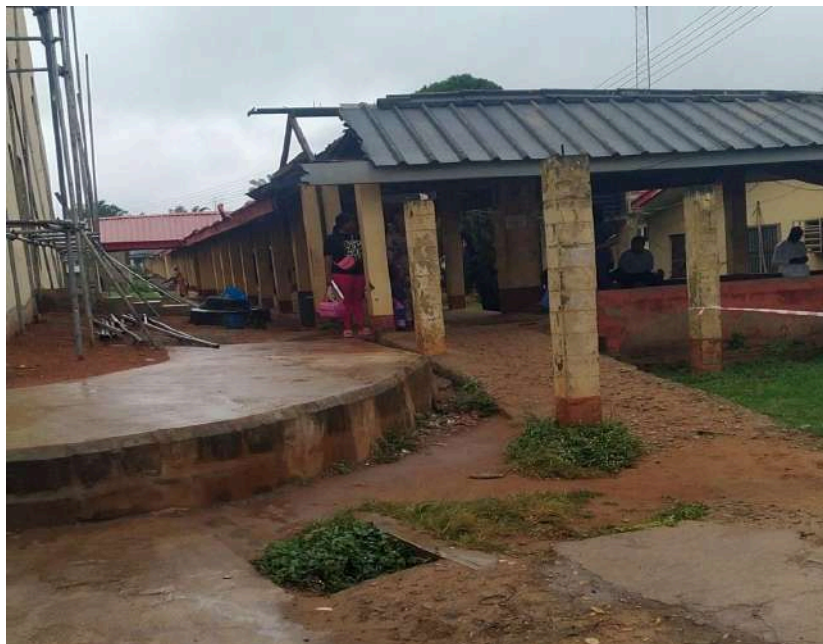
*Plate 4: The entrance to the older building clusters and its ramp*

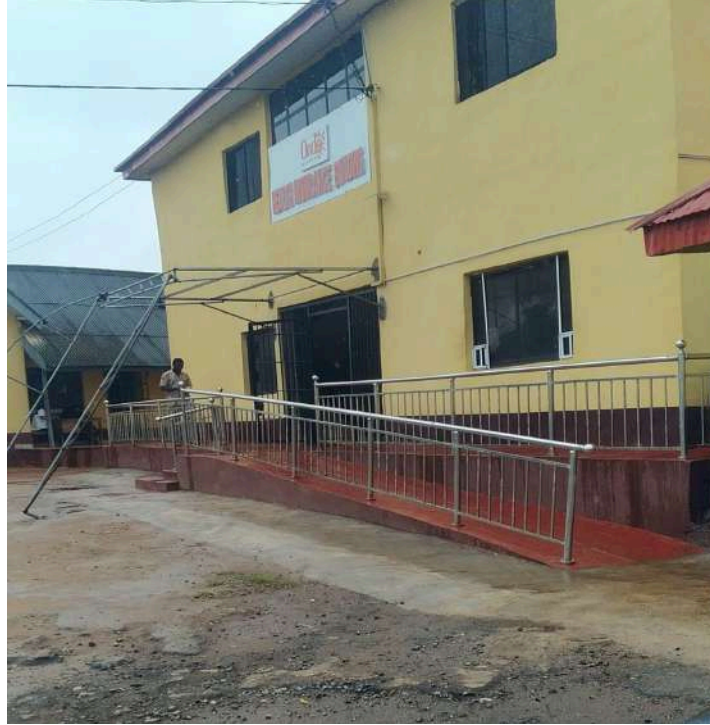
Another respondent also believes the accessibility is top-notch, as the ramps are properly positioned and connected to the main roads. The only inconsistent buildings with a lack of accessibility features are buildings donated to the hospital by organisations. However, a major problem with the existing accessibility feature is the lack of maintenance, as many of them are worn out and require maintenance.

*Plate 5: The entrance to the health insurance building*

The recommendations for better accessibility from the respondents include adding railings to where ramps and stairs are, alongside positioning the ramps on the side of pedestrian entry of the entrance gate of the hospital. Consistent maintenance is also recommended, but in all, the accessibility of this healthcare facility was rated very highly.

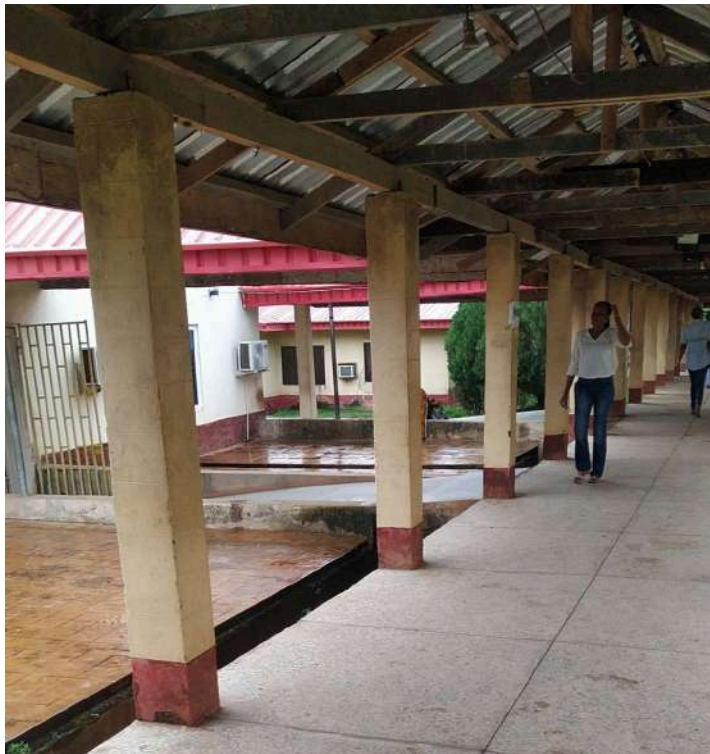
*Plate 6: The walkway between buildings and their entrance points*

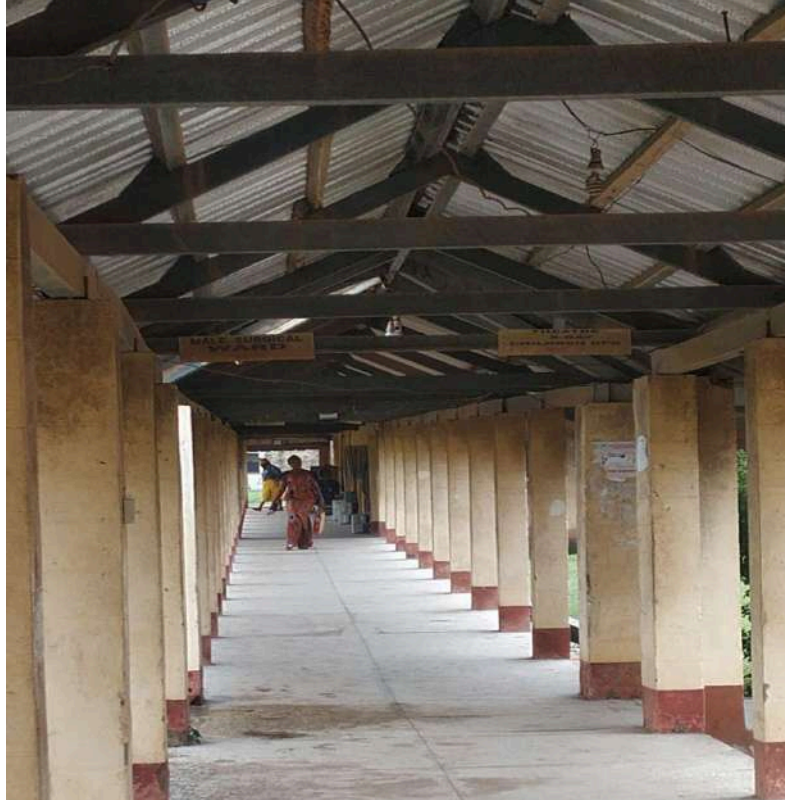
For usability, mostly in terms of wayfinding, all respondents rated the Ondo State Specialist Hospital perfectly on wayfinding due to the strategic positionings of signs and directions for people of all ages and abilities to find their way around.

*Plate 7: The walkway and the signs showing each building*

Recommendations for better wayfinding with this healthcare facility are clearer signs and options in braille and larger signs for people with low vision. Also, the signs on the walkway are recommended to be bolder and less far from the ground,

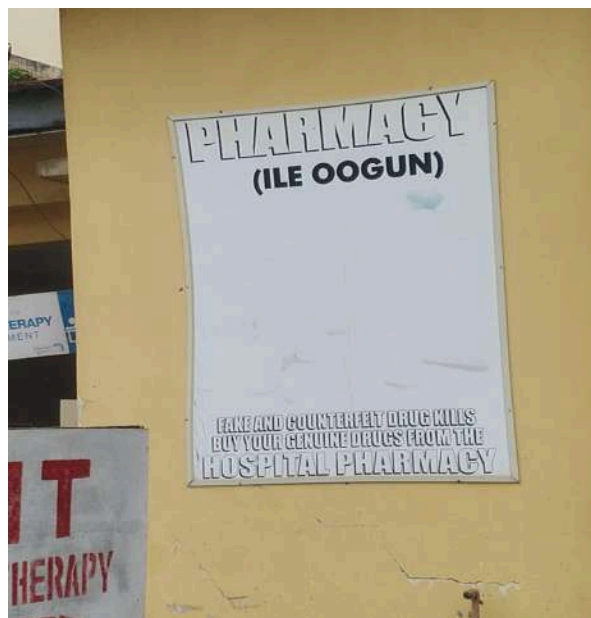
*Plate 8 The signage to the pharmacy in both English and Yoruba*

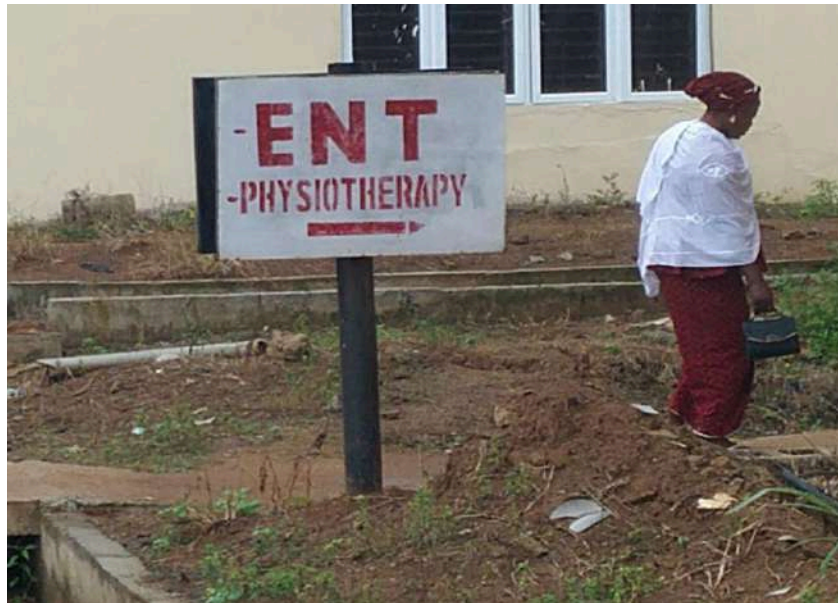
One of the respondents believes that with the sign on the walkways of the hospital, it is easy for anyone who is ill or even just visiting to find their way around without asking too many questions. Another respondent also highlighted and praised the use of the native language, Yoruba, in some of these signs and pointers, making it more usable for a wider demographic audience.

*Plate 9: The signage to ENT and physiotherapy building*

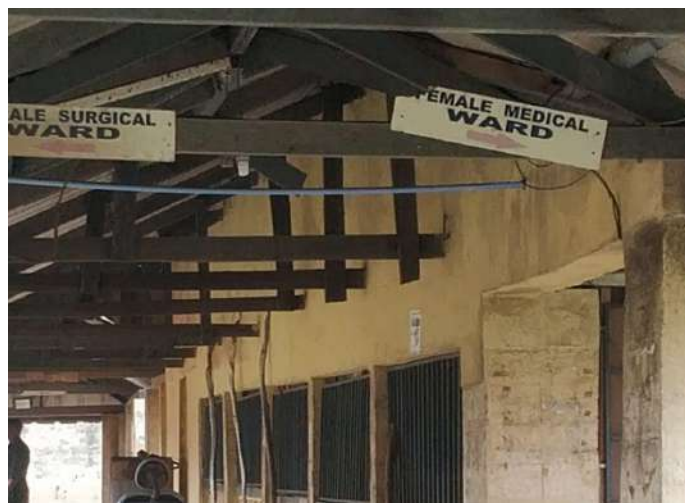
*Plate 10: The signs showing each building in the walkway*

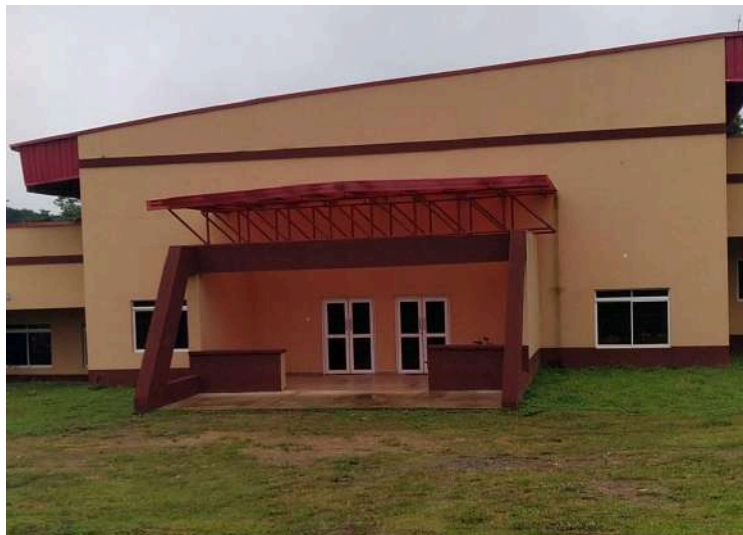
*Plate 11: The main entrance to the building*

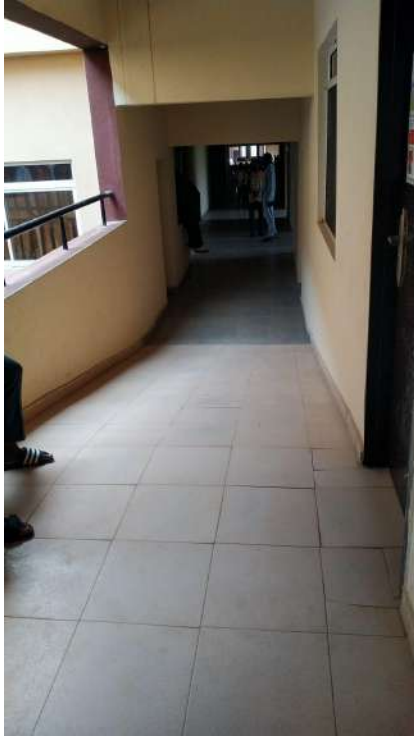
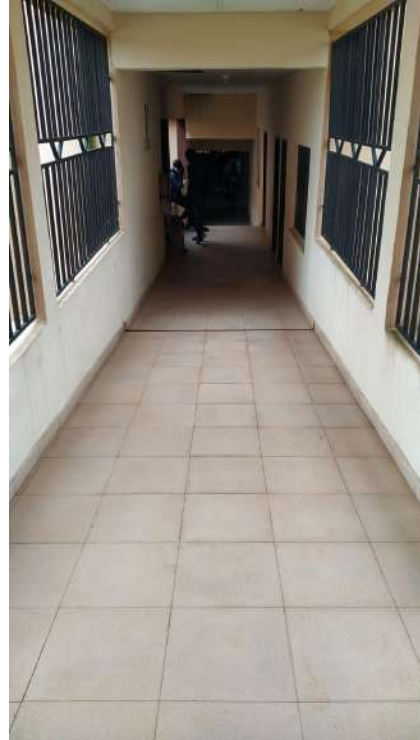
The buildings are built on sloppy land as the site topography is sloppy, and as a result, there are multiple changes in the level of the buildings. However, the connecting factor of these buildings is walkways in the form of ramps and concrete pad walkways. Many ramps are used all over these buildings as there are many level changes. The slopes of these ramps differ according to changes in level. The entire building is tiled in slightly slippery tiles alongside courtyards directly positioned beside the walkways.

*Plates 12&13: The walkway ramps within the building*

There are no signs showing directions across the multiple buildings in this healthcare facility. Getting around requires questions about directions. Also, the walkways between the buildings at the front and back could be clearer. The walkways also do not have any cover or canopy, making them open to harsh weather conditions.

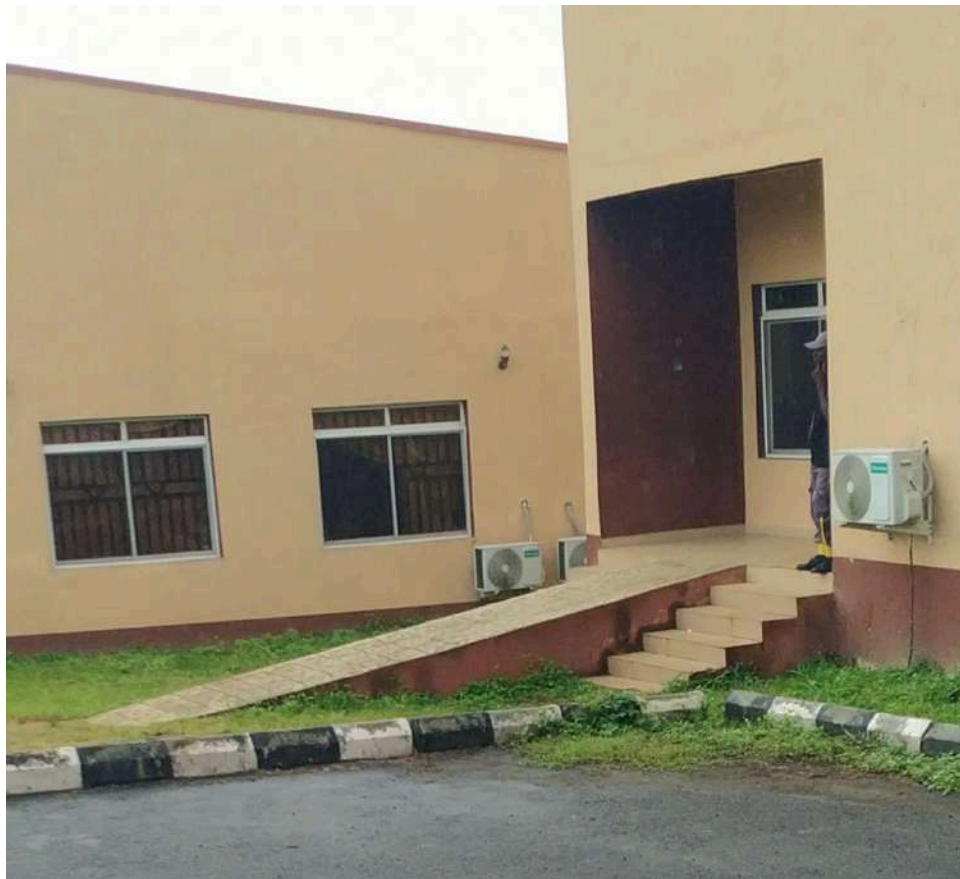
The accessibility of this healthcare facility evoked mixed feelings from the respondents. On the one hand, a number of the respondents believe that the accessibility features of this facility, which include ramps of different lengths and slopes and walkways across and between buildings, are just okay, meeting the bare minimum requirements.

*Plate 14: The pedestrian entrance to the building*

The recommendations for what could be different include using shades and canopies for external walkways, using nonslip tiles within the building, creating ramps with better slopes and possibly leaving the building at the same level, reducing the energy required for ill and people living with disabilities to move around.

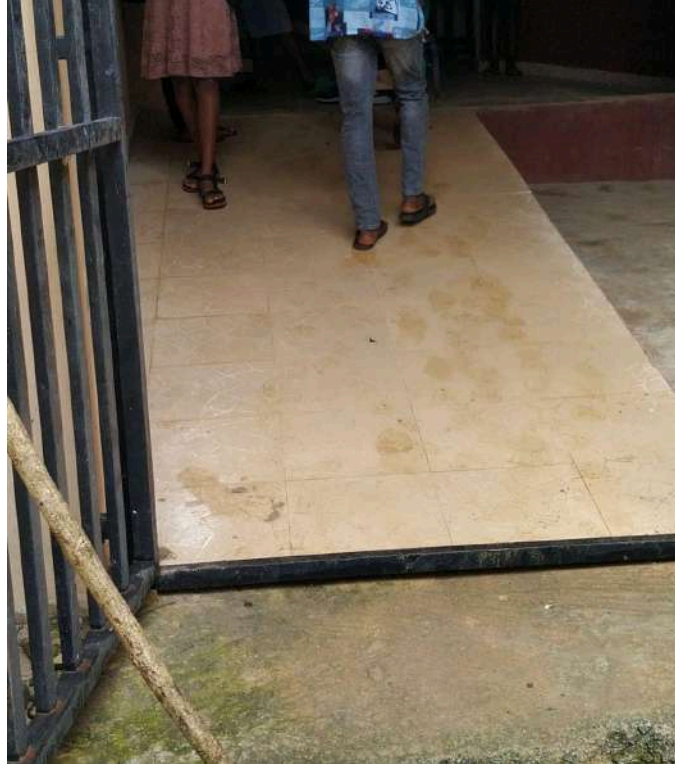
The ramps do not have railings and are susceptible to getting wet due to their proximity to the courtyards, attracting rainwater from winds during the rainy season. Also, a respondent pointed out that most of the external walkways do not have shades or canopy, leaving users to walk and move around in the open, especially during harsh weather conditions.

*Plate 16: The ramp from the medical records room to the external walkway*

While accessibility features are present, they are not in good condition, do not meet the architectural standard and will, in turn, cause more harm than good in the long run.

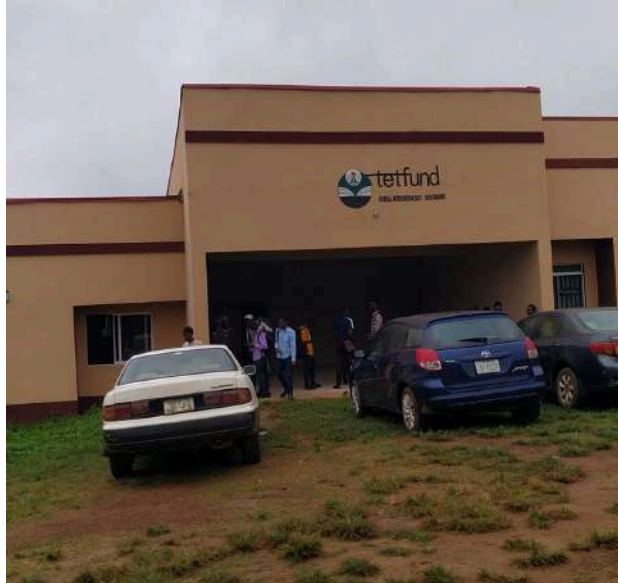
Regarding usability and wayfinding in this healthcare facility, all respondents believe that wayfinding needs to be more present in this building. As the entire structure is scattered with buildings in different parts of the site, connected by walkways, it is essential for signs to point out which building is which. However, there are no such signs. According to one respondent, usability is very hard in this building. A sick person would not have enough strength to move all around and would be very confused and disoriented because there are no signs.

*Plate 18: The secondary entrance to the building*

Usability recommendations include creating a clear and understandable map at the entrance of the buildings and having signs at strategic places in English and vernacular languages for people to understand.

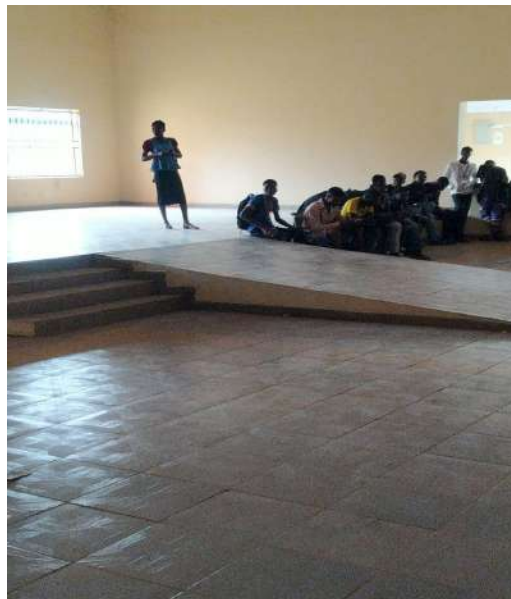
*Plate 19: The reception and its ramp*

Other respondents also believe that the arrangement of the services could be more reasonable as they do not ease into each other. They are mostly from one point to the next and back to point one again, similar to a Brownian motion. Therefore, respondents perceive usability and wayfinding as nearly impossible.

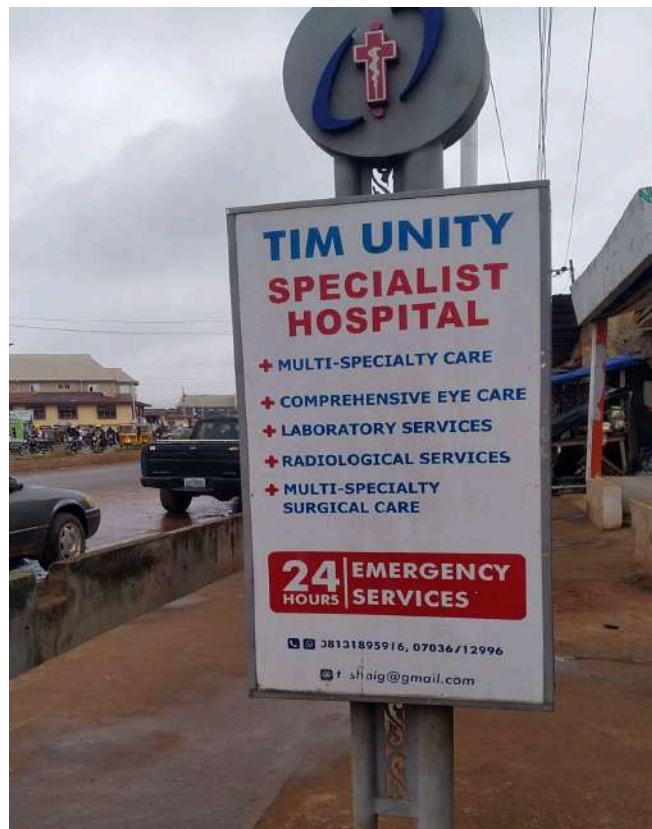
*Plate 20: Signage directing users to the hospital*

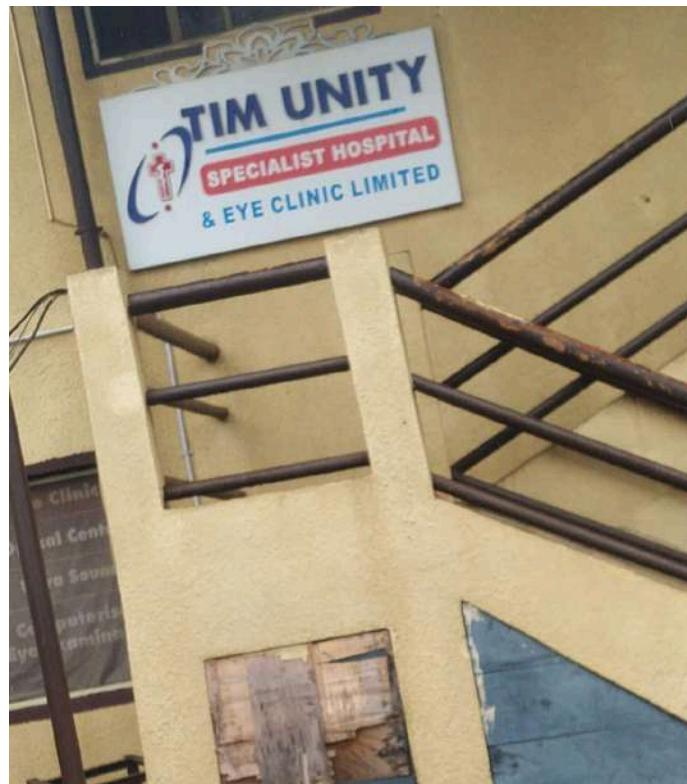
*Plate 21: The signage and stairs for the building itself*

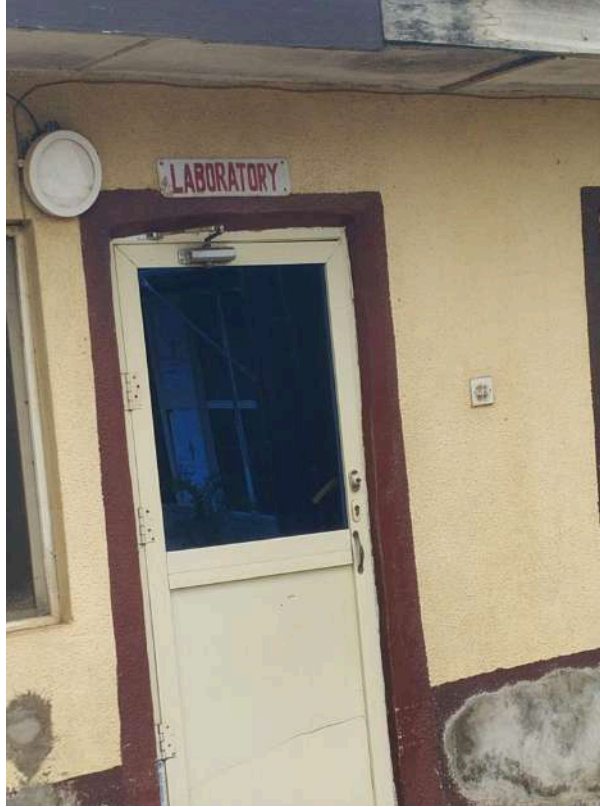
*Plate 22: The signage for the laboratory*

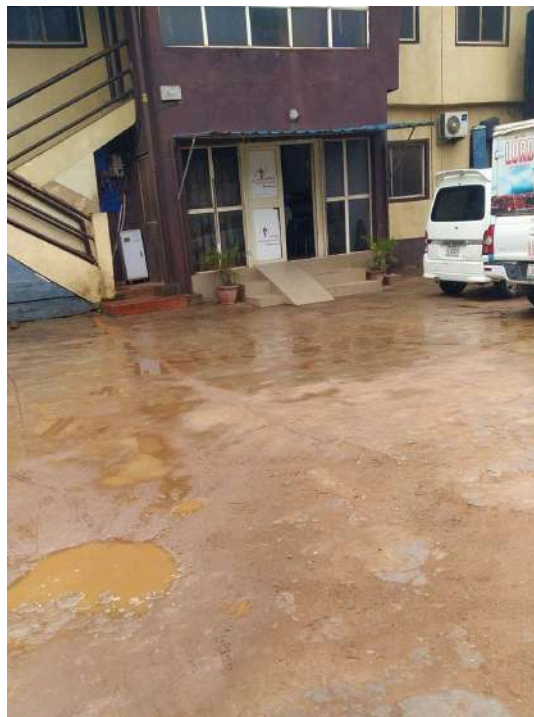
For the accessibility of this private hospital, there was a unanimous agreement and uniformity among the opinions of all respondents that the accessibility of this healthcare facility is on the bad side. With the design lacking the presence of accessibility features and barely meeting the required standard of a healthcare facility, the respondents believe that the bare minimum facilities used, such as ramps and railings, were created to satisfy all requirements. However, execution was poor, making it completely useless.

*Plate 23: The entrance and parking lot of the building*

The recommendation for this is the incorporation of ramps that meet standards and designing hospitals with more space to ensure there is enough space to allow people of different mobility issues to move around conveniently.
